Introduction

A Case Study

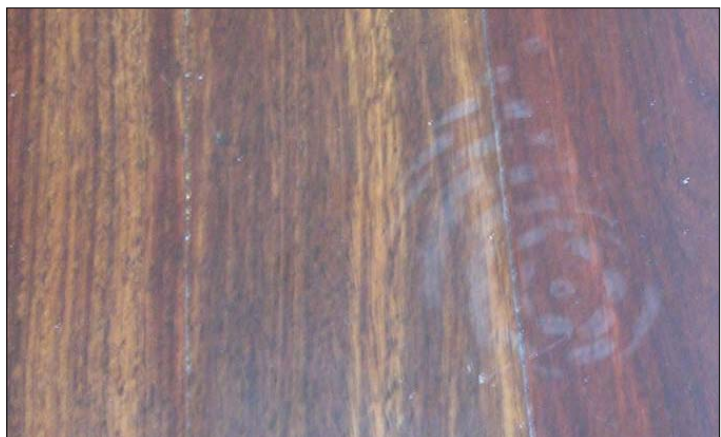
The only area of ghosting on the upper level was adjacent to the ensuite. Due to the location, this area would have been coated first and all of the floor would have been walked on to get to this area. Has a contaminant come from the ensuite, an area that was tiled/marbled some considerable time earlier? Notice that the mark is across two boards and the twisting of the foot.

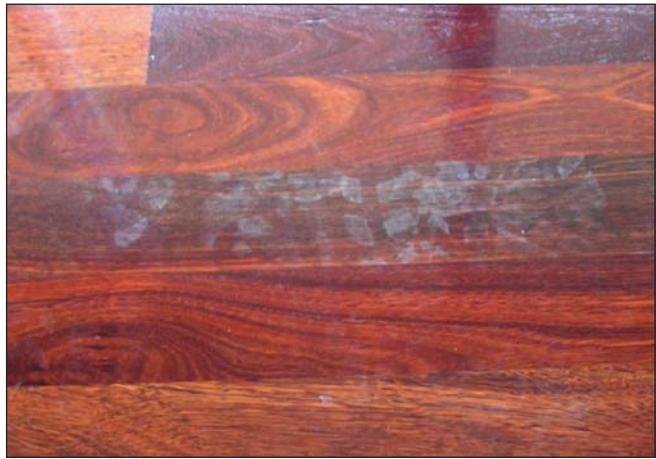
Prints mainly confined to one board and not adjacent boards. Does this suggest that the board or the drying of the sealer or coating on that board had an influence?

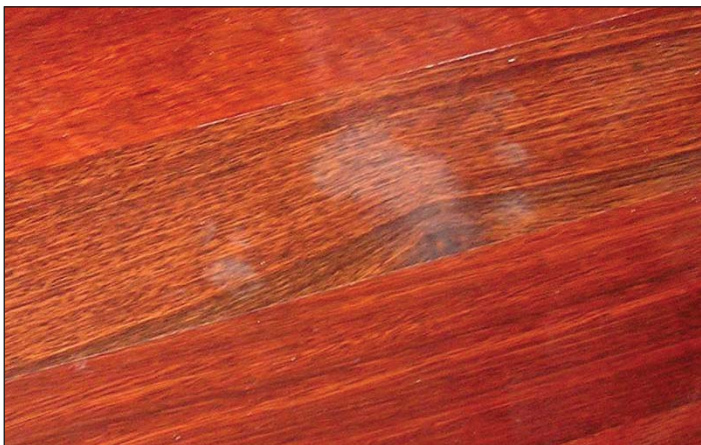
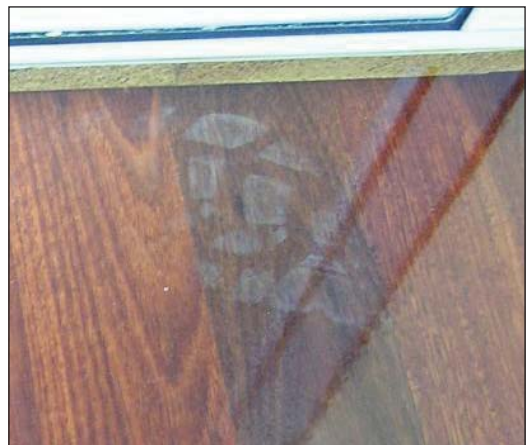
Bare foot print in the lower left photo. However, there were possibly only two or three bare foot prints discernable over the whole floor. The photo on the lower right shows a different style of boot mark at one of the patio doorways in the lounge.

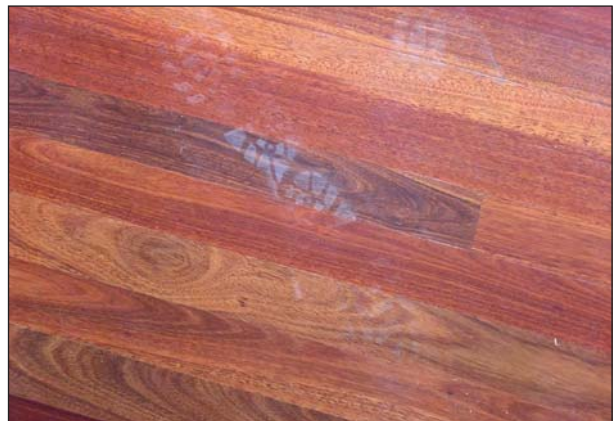
Highly developed prints in the main entrance and note the predominance in one board but also progressing into adjacent boards. Note also the two heel marks facing opposite directions. It appears to have resulted from the person simply walking in and out of the dwelling.

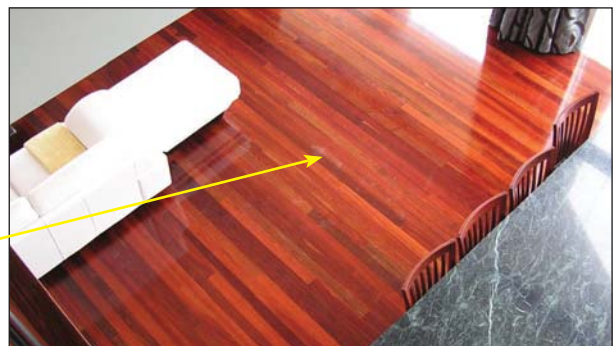
This is the lower storey lounge floor with the photo taken from the upper level. A highly developed boot print as shown in the inset is present in the middle of this floor. Note how areas either side of this area are not affected to a significant degree.

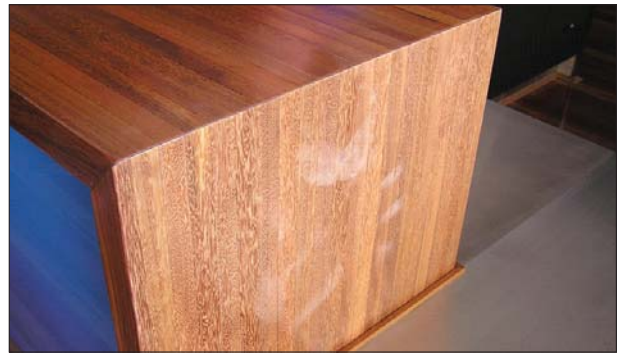
Associated with the adjacent photo, the floor was sanded and finished after ten or so years of use. The bench shown in the photo, also coated ten or so years earlier, but not part of this refurbishment, it had a plastic drop sheet placed over it and after the floor was finished and the drop sheet removed, these hand marks became immediately apparent on the bench.

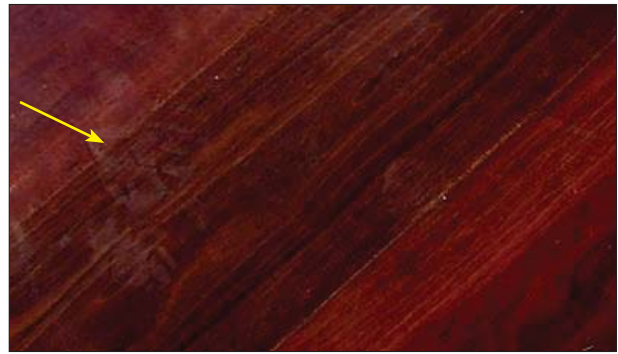
In this dwelling the coating had been down for two years. The family dog killed a possum that had come into the house and after this, the ghosting shown here appeared over the following months. Note the shoe print arrowed.

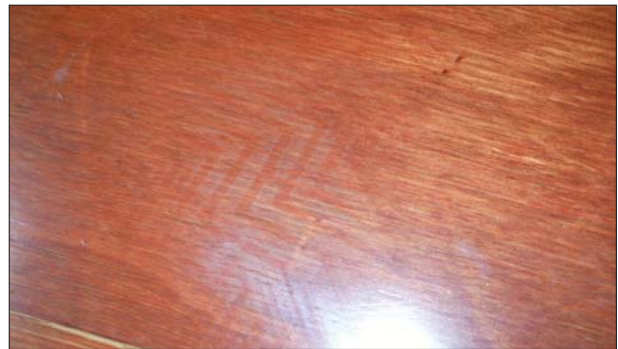
This mark was reported to have appeared soon after the floor was recoated seven years after initial coating.

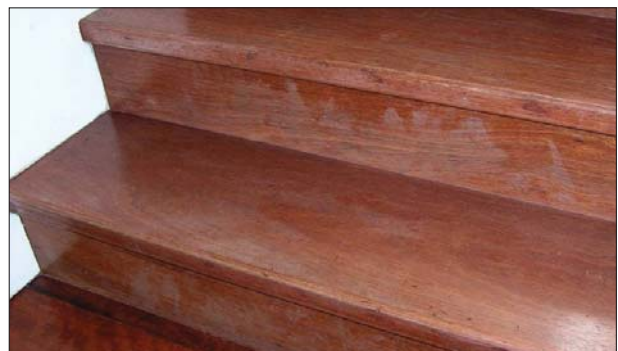
Ghosting does not always appear as foot prints and it does not always appear on horizontal surfaces. In this final example the ghosting appears more predominantly as smudging in the stair risers. In other instances boot prints have been observed in stair risers.
