Introduction

This information sheet outlines reasonable owner expectations for onsite sanded and coated timber floors, which generally applies to solid T&G flooring and parquetry. Concerning floor acceptability, there are performance aspects of the floor which can relate to fixing integrity, board shape and movement, and then there are appearance aspects which focus more on the sanding and finishing. The sanded and coated appearance aspects of this information sheet will also be applicable to some other flooring types (e.g. engineered flooring that receive site sanding and coating). Although an imperfection free floor is the desire of any tradesperson, it is the process of installation and finishing where the environment and other conditions cannot be fully controlled that moves the completed job to one that is 'normal' and of a commercially accepted standard. This however is not to say that the completed floor won't be of a high standard and well suited to its purpose as a floor, which is to be walked on, but it does acknowledge that the finished product will not be the same as fine furniture and that due to seasonal influences and heating and cooling, that some movement reflecti

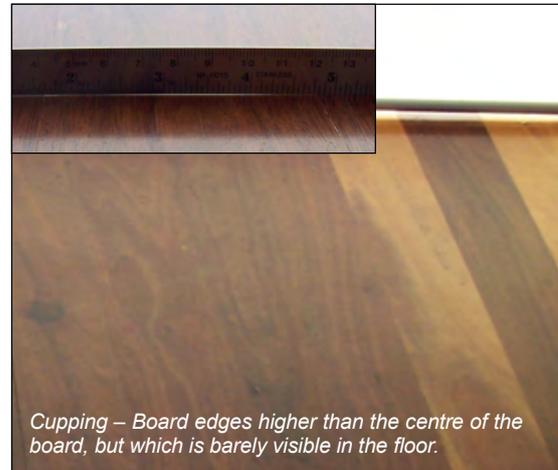
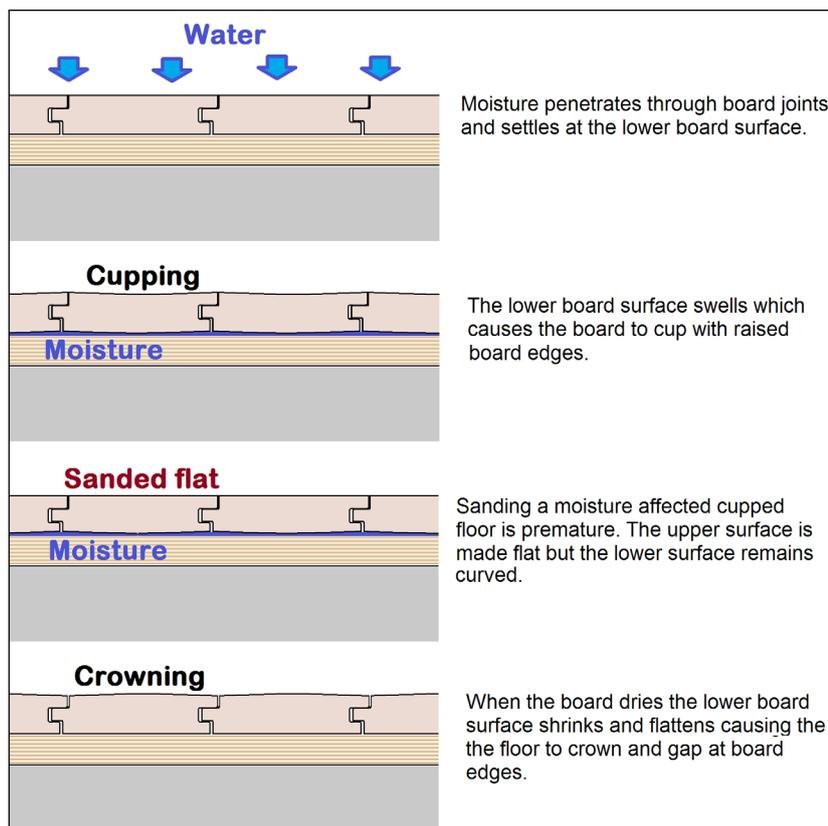
- **Cupping** – boards with their edges either higher or lower than the centre of the board. Heat in a specific location or a very dry environment above the floor may result in cupping. Moist subfloor spaces can also cause boards to cup. Cupping is more likely to be observed in overlay flooring and standard thickness boards that are wider than 100 mm. To some degree a small amount of observable cupping may occur in some locations within a dwelling (e.g. sun exposed floor) where these types of flooring are used.

- **Peaking** – this has the appearance of cupping but is the result of expansion pressure in the floor.
- **Tenting** – two adjacent boards, where the adjoining edge has lifted above the level of the adjacent flooring. This is often associated with high moisture beneath the floor and can be from many causes.

- **Buckling** – a section of flooring containing a number of boards that is raised above an adjacent section.
- **Crowning** – floorboards that are flat on their lower surfaces but where the upper surface has its edges lower than the centre of the board. Crowning in timber floors occurs when a floor has become wet, has cupped and then is sanded prematurely before the moisture imbalance between the top and bottom of the board has balanced out. Crowning does not become apparent until some months after finishing.

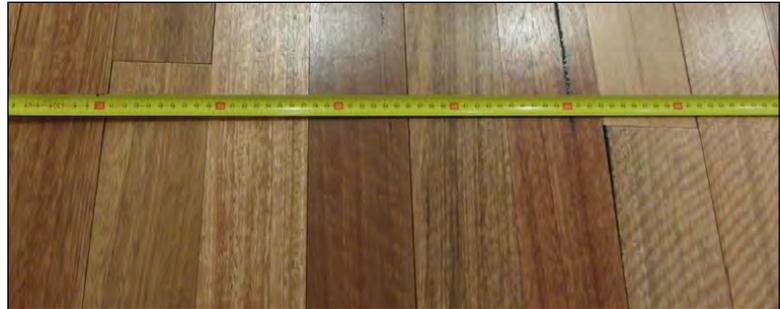
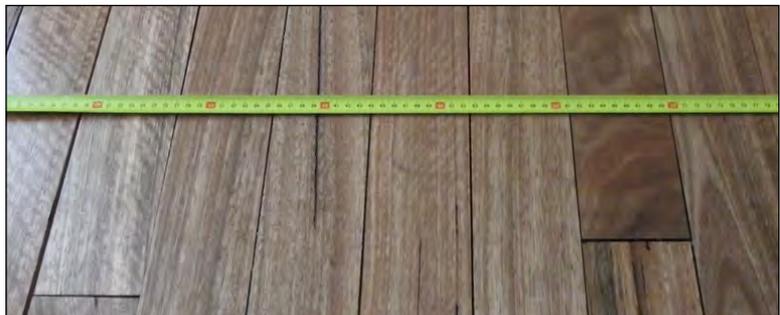
The first photo which is considered acceptable, has gapping near the upper limit where the average gap size was 0.75 mm and the second photo has gapping that is not considered acceptable where the average gap size was 1.8 mm. Note that it is the average gap size over 10 boards so some gaps are greater than the average and other less than the average.

With solid timber strip flooring shrinkage gaps over 10 boards can average 0.75 mm for an 80 mm wide board floor under drier internal conditions. For wider boards, proportionally wider average gapping can be expected. The appearance should indicate gapping between most boards and be free from irregularly spaced wide gaps associated with edge-bonding. The provision of expansion gaps as part of the installation process and evident throughout the life of the floor is acceptable.

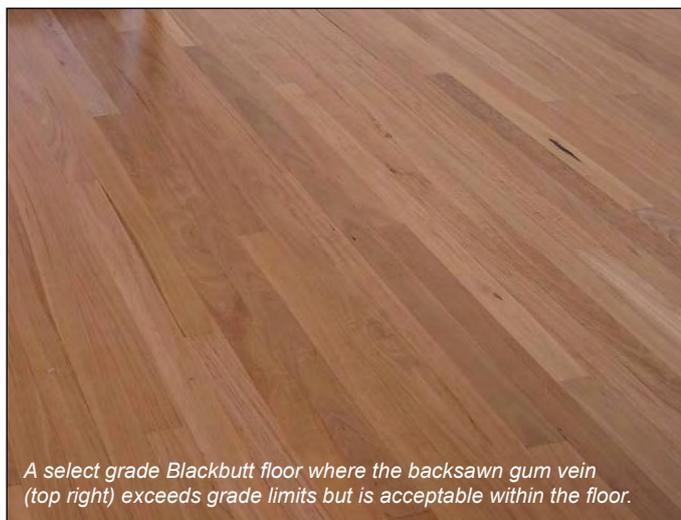
A select grade Blackbutt floor where the backsawn gum vein (top right) exceeds grade limits but is acceptable within the floor.

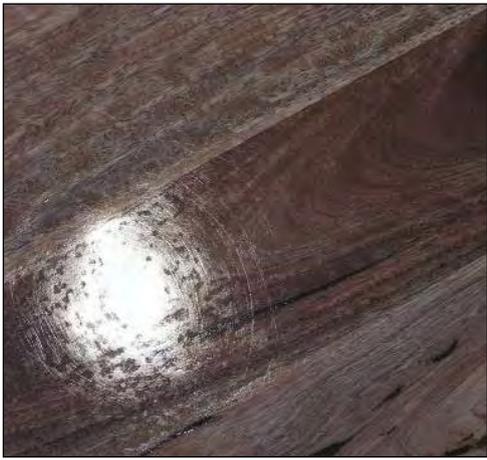
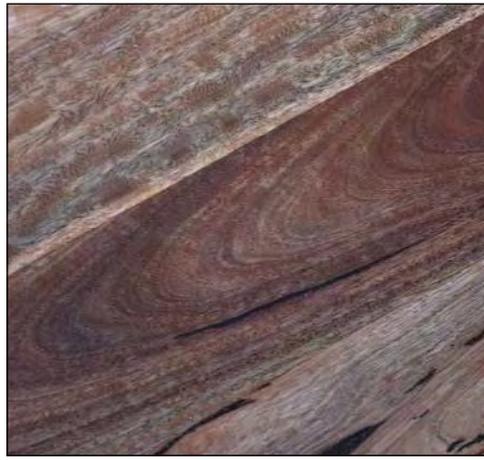
The photo to the left shows circular swirl marks that are visible under down light. The photo to the right shows the same section of floor in natural light without the down lights on and the swirl marks are not visible.

- **Swirl marks** – Swirl marks are caused by rotary sanders and to some degree will be present in all floors. Down lights will highlight sanding imperfections due to light refraction through the coating and as such this is not controllable by the contractor. Fine swirl marks that are not obvious under natural light when assessing a floor should not be a concern.

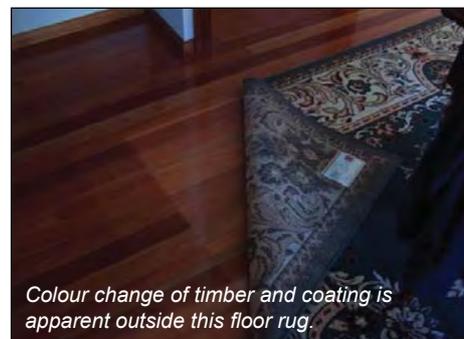
Colour change of timber and coating is apparent outside this floor rug.

Over the course of time colour changes occur in timber floors from the effects of ultra violet light. Therefore, it is usually more pronounced in sun exposed areas of the floor. This is partly associated with the changes in the timber and partly with the coating that is applied. Some coatings darken with time more than others and some timbers are more prone to colour changes than others. This process is natural and often gradual but can result in distinct colour differences where rugs have been put on the floor. Some of this change can be minimised by not putting rugs down till six or so months after the floor has been completed. It is beneficial for flooring contractors to make clients aware of how the coating used may result in colour differences. From there it is up to the owner to manage how rugs are used.
