Introduction

This information sheet outlines reasonable owner expectations for engineered, laminate and bamboo floors. An acceptable finished floor will differ to that of solid timber flooring due to differences in product characteristics associated with manufacturing and installation processes. Even within a flooring type, differences in both performance and appearance occur, as do manufacturer installation requirements. Specific installation techniques differ when products that are adhesive fixed to the subfloor are compared to those that are floated even when the same product is used. These product types are mainly manufactured in Europe and Asia and are therefore manufactured to differing overseas standards. The ATFA has more detailed information on each product type and installation practices in their industry standards, available for purchase on the ATFA websites. A more general understanding can be gained from the brochure 'Timber Flooring Applications' also available on the ATFA websites.

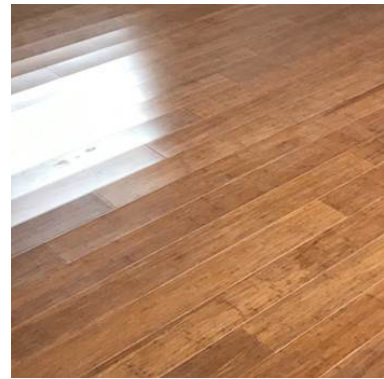
Excessive cupping in a floated bamboo floor from subfloor moisture beneath the floor

- **Cupping** - Cupping, with board edges higher than board centers, is generally associated with bamboo flooring and at times engineered flooring but not usually laminate flooring. The cause is often moisture from beneath the floor causing greater expansion of the lower board surface and this causes the cupped appearance. However, with engineered flooring an imbalance in the moisture content of the face layer (lamella or veneer) can also cause boards to cup. Minor cupping can also be associated with a very dry internal environment. Consistent cupping that is visible throughout a floor in more than glancing light is not considered to provide an acceptable appearance and nor where the cupping is the result of moisture effects from beneath a floor. However, where heating systems or direct sunlight impinge on a floor causing some localised cupping, it should be accepted. Maintaining conditions of low internal air relative humidity below the limit indicated by the flooring manufacturer would also be considered owner induced.

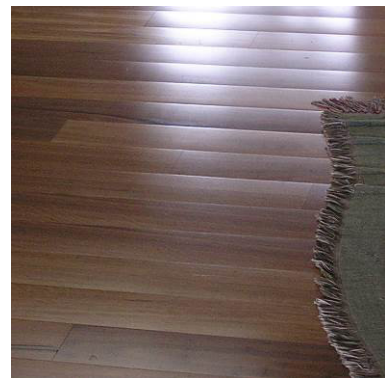
A floated floor crowning in the tropics with a high-density face timber. This degree of crowning is excessive.

- **Crowning** – Crowning, where the center of the board is higher than the edges, can be associated with engineered flooring but does not occur in bamboo or laminate flooring. When the floor is in an uncontrolled naturally ventilated environment, the flooring can be expected to absorb moisture from the humidity in the air. This will often cause some swelling of the face lamella, but the overall effect on the board will differ depending on the board construction, face lamella thickness and also the ‘strength’ of the species in the face lamella. Crowning can also occur if the face lamella has been manufactured at a very low moisture content. It is therefore more common in flooring with high density thicker face lamellas and with floated as opposed to adhesive fixed floors. Boards should not have a visibly crowned appearance when removed from new boxes and only minor crowning should be expected in an in-service floor. As crowning is affected by air humidity, aspects of lamella species and thickness, installation method and manufactures stated optimum humidity range for the product, all need to be considered.

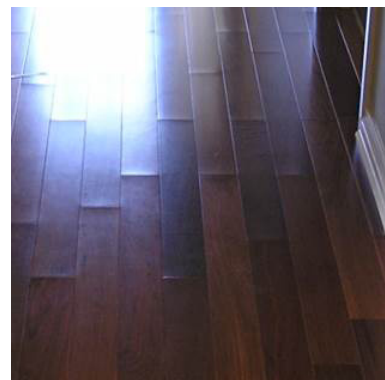
This is an adhesive fixed strand-woven bamboo floor with excessive end-peaking.

- **Peaking and end-peaking** – Peaking relates to raised boards edges but differs from cupping in that it is pressure related not moisture related. As well as raised board edges from pressure it is also possible to get raised board end-joints known as end-peaking. End-peaking can be from pressure effects and also from laying boards that are more severely bowed (boards with their ends more severely curved upward), causing end-joints to be proud. Peaking and end-peaking can occur in engineered, bamboo and laminate flooring and in floors that are floated and adhesive fixed. But both forms of peaking can often be avoided if the floor is properly compartmentalised and with appropriate expansion allowance provided. Manufacturers generally indicate that in addition to perimeter movement allowance (accommodating shrinkage and swelling of rafts), floors across doorways can need control joints and a floor can only be of a certain width and length before intermediate movement joints are needed. This is for both floated and adhesive fixed floors and noting that requirements are manufacturer, product and installation method specific. Insufficient expansion allowance and insufficient compartmentalisation can therefore be factors contributing to peaking and end-peaking. Product supplied at low moisture content or with pronounced bow can also contribute. Peaking or end peaking that is minor and only apparent toward glancing light sources may be considered acceptable.

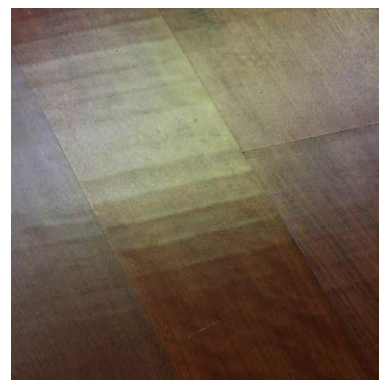
Telegraphing in an adhesive fixed engineered Oak floor.

- **Telegraphing** – This only occurs in block construction engineered flooring and has the appearance of regular stripes across the width of the boards. It can be due to both product manufacture and moisture effects causing differential swelling within the block core layer. Manufactured related telegraphing can be caused by inconsistency in the thickness and moisture content of the blocks beneath the face lamella and products with thinner face lamellas will be more susceptible. If a floor is moisture affected, then this too can cause differential swelling of the block core layer and cause telegraphing to develop in the moisture affected area. If very minor and only apparent toward glancing light, it may be considered acceptable.

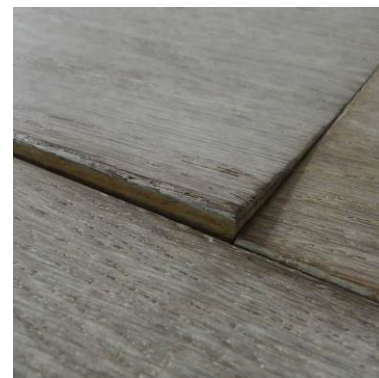
Lamella delamination

- **Lamella and board delamination** – In engineered flooring separation of the face lamella is considered a manufacturing fault that is covered by most warranties providing the fault develops in the floor after it has been laid. In such cases only the occasional board is usually affected and can usually be repaired. Changes in the internal climate to a much drier in-service environment can create conditions that will stress the adhesive bond between layers and make boards more conducive to not only delamination of the lamellas but can also cause splitting of the plywood base layer in boards of that construction. The splitting is often beneath the groove edge of boards having a tongue and groove (T&G) jointing system and this may correct itself with more humid conditions. Products can be expected to perform when the internal climate is within the specified acceptable humidity range indicated for the product. Note also that localised hot dry conditions exceeding manufacturer acceptable ranges can be induced by more extreme use of heating systems.

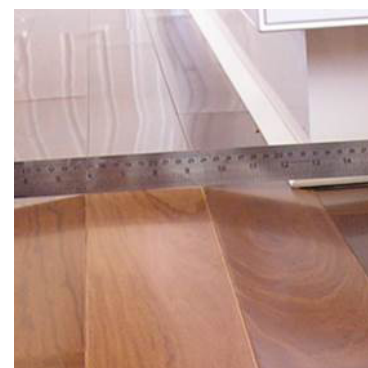
Buckling due to insufficient expansion allowance

- **Buckling** – This is mainly with floated floors and is where a section of boards rises up above the normal floor level. A common cause is insufficient provision for floor expansion being incorporated into the floor at the time of installation. As indicated above, compartmentalisation is the breaking up of the total floor area into a number of smaller areas, often referred to as rafts, with the rafts connected by trims. This along with adequate provision for expansion to all walls and vertical surfaces is needed to prevent buckling. If a floor expands with insufficient allowance for movement being provided, then the floor will buckle and be in need of remedial work.

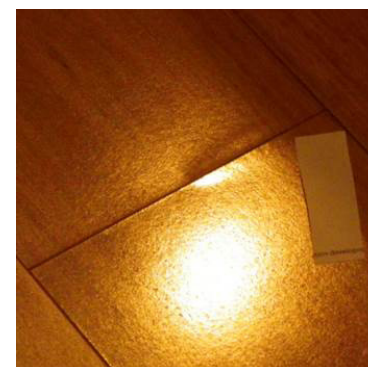
Moisture affected laminate flooring

- **Swelled edges from moisture** – Laminate flooring varies in its resistance to being affected by moisture and some laminate flooring is now manufactured as a water-resistant product. However, no laminate flooring can sustain high levels of moisture over extended periods. With some products, spills need to be mopped up as soon as possible, others can sustain a spill for a few hours and moisture resistant products should

not be affected by small spills. If moisture is adsorbed at board edges or ends, the fiberboard core will swell and will remain in a swollen state even when the flooring dries. Product warranties generally outline the resilience of the flooring product to moisture ingress and should be viewed. Board replacement is necessary to address boards that have swollen, provided spare boards are available.

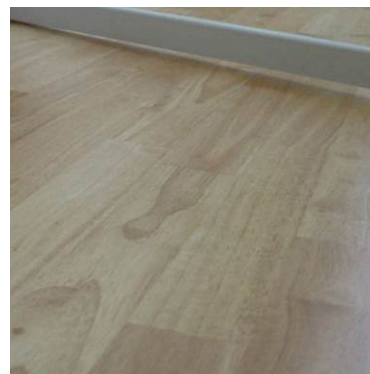
Buckling of the floor inducing creaking and excessive movement under foot.

To a degree timber floors are known to have an occasional creak or squeak, and this is often evident in older buildings. However, with products that are adhesive fixed, including solid timber flooring, squeaks or creaks with this installation method seldom occur. When it comes to floated floors laid on a foam underlay, no slab or other subfloor type is perfectly flat and it is therefore not unusual for floated floors to have some creak or other noise, as foot pressure will deflect board joints and rubbing within the joint can cause a creak sound when the floor is walked on. Noise from a floor can be weather related and, in some instances, only occur when the floor is walked on for the first time each day. Factors that can contribute to noise from a floor are the flatness of the subfloor, slight buckling of the floor from insufficient movement allowance, underlay thickness, warp in the boards and board joint design with associated tolerances. Each of these aspects affect the movement within board joints when the floor is walked on and highlights the importance of adhering to the installation instructions for the product and particularly subfloor flatness, underlay thickness and adequate movement allowance provided at installation. Glueless jointing systems generally have waxed surfaces and this can assist with reducing noise but not necessarily prevent it. Noise that is not loud or only occurring in some areas of the floor is generally considered acceptable. However, if the noise is both very audible and present in main walkways or very audible and consistent when walking throughout most rooms in the house, remedial work needs to be considered.

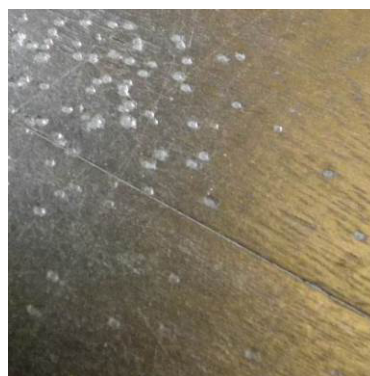
Oak is not as hard as Spotted Gum.

Indentations and scratches relate mainly to engineered flooring due to the variety of timber lamella species used and that these products are either factory coated, or site sanded and finished. Indentation resistance is governed by the hardness of the floorboard and this is influenced by the species, lamella thickness and core layer hardness. When hardness is documented with engineered flooring, it usually refers to the published hardness of the lamella timber species and not the hardness of the engineered board. So, some care is needed when considering this. However, with much of the flooring having a lamella thickness of at least 2.5mm, a species of significantly lower hardness will be more prone to indentation than one with a higher hardness value. It is generally up to the purchaser to be aware of the hardness of the chosen flooring, with indentation seen as relating to floor care and not product manufacture or installation.

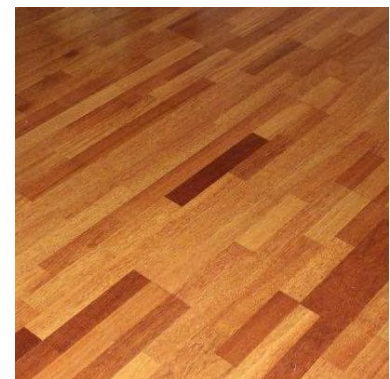
A 3-strip engineered floor

- **Board length and laying pattern** – When engineered, laminate and bamboo flooring is laid on a structural subfloor, products are often a set length for laminate or bamboo and either set length or nested lengths for engineered, with lengths commonly up to about 2.0m. Some products are however supplied longer length. At times engineered and laminate flooring is termed ‘one-strip’, ‘two-strip’ and ‘three-strip’ and this refers to the number of widths of face lamellas covering the base layer. Hence two and three strip flooring have the appearance of ‘end matched joints’ aligning at the end of each board. The face of the board is also made up of many short to very short pieces and it is quite common with this type of product to have end joints in close alignment.

With this product the general expectations for solid timber flooring do not apply where it would be usual to stagger end joints 300 to 450mm apart. But when the appearance is to replicate that of a solid timber floor, then general expectations are that the floor in terms of end joints will also be similar to those for solid timber floors. With floated floors some manufacturers also require end joints to be at least 150mm apart to ensure integrity of the locking system. At times with set length boards there can also be an intention to create a regular pattern in the floor. Therefore, there are few specific requirements when it comes to laying patterns with these products and it requires discussion between the parties prior to floor installation. Do not assume the other party has a similar view on board layout to you. Also, the only requirements are those if specified in installation instructions.

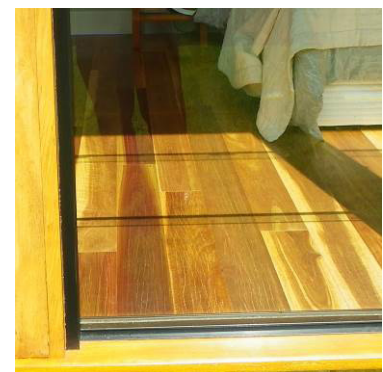
Intense unfiltered sunlight causing checking is an owner responsibility.

- **Surface checking** – A check is a separation of the wood fibers and shows as a split in the lamella surface of engineered flooring. Such checks can be present at the time of manufacture and are filled, along with other open features. These are considered as a characteristic of the product. However, post manufacture checking can occur in boards both prior to and after laying. Checking is also influenced by the internal conditions. Very high humidity that can cause crowning, will also stress the face lamella and may result in checks. Similarly, a very dry internal environment or intense unfiltered direct sunlight can result in boards checking. Hence, owners also have a responsibility in looking after their floors. If the checks are more extensive across the floor and not associated with very dry internal conditions, then manufacturing aspects may need to be considered. Minor checking after installation in a limited number of boards is not usually a reason for concern and if checking is observed prior to laying that section of the board should be removed.

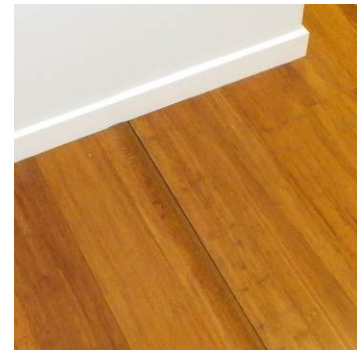
Board separation due to insufficient compartmentalisation

- Gapping at edges and ends** – Many engineered, laminate and bamboo flooring products have glueless jointing systems for both edge and end joints and with such systems no significant gapping at board edges and ends should be expected. Some engineered and bamboo flooring has a tongue and groove (T&G) jointing system and if laid as an adhesive fixed floor they will be more like a solid timber floor and minor gapping can occur. If boards with a T&G jointing system are floated, then adhesive used in the T&G joint, that should prevent any significant gapping at board edges and ends. Minor gapping is possible in installations of all types due to seasonal movement and boards not being absolutely straight down their length, and such minor gaps are generally not highly noticeable and are to be accepted. In some cases, a filler may be used if of concern. Wide gaps and particularly where the jointing system has separated, requires remedial work. Note that with floated floors, if insufficient attention is given to subfloor flatness, compartmentalisation and underlay thickness, then board separation can occur. Similarly, the design of the locking system and particularly at end joints can play a role. Insufficient or inadequate adhesion and if crosslinked PVA is not used in T&G joints, this can also lead to board separation in that type of flooring.

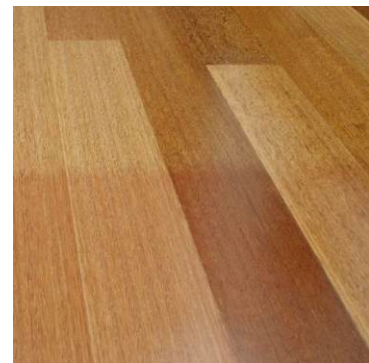
The floor presents as being darker where it had been covered by a rug

- Colour** – At times flooring is selected based on species and at other times, particularly with pre-finished flooring on both coated colour and texture of the boards. Some coloration disguising the species while other coatings enhance the species appearance. Concerns with colour are usually associated with engineered flooring as laminate flooring usually has a set number of images and thereby consistency across batches and bamboo flooring a more uniform appearance. It needs to be considered that particularly with engineered flooring there will be changes in timber and coating colour over time and if the flooring is partly covered by floor mats, a difference in colour tone will occur. In some instances, the variation in tone will be more subtle but in other instances more intense. On a new floor the laying of floor rugs should be delayed which allows the whole floor to change colour more evenly, noting that colour change reduces with time. In most instances colour change needs to be accepted as a natural characteristic of the product.

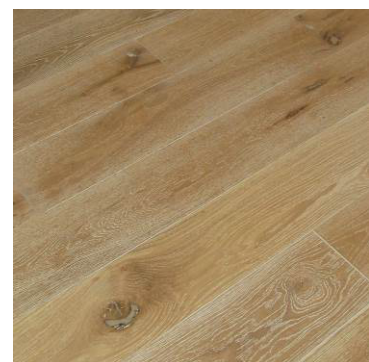
An ABCD grade Oak floor coloured to enhance the grain and with open features filled

- Grade** – Grade relates to the features (such as knots or gum veins) in a board and such features add character to a floor. Often engineered flooring is sold based on the appearance of samples and brochures with no particular grade being specified. Some flooring with Australian species in the face lamella may however be graded to the rules of its solid timber counterpart. With Oak flooring the grade is often specified as ABCD grade, but the rules around this can vary depending on the country of origin. This grade name is really a mix of grades, with some boards having a lot of feature and other boards minimal feature. Concerns arise when the flooring has a different appearance in terms of features to what the purchaser was expecting. This is usually more feature in the boards rather than less but also may relate to the size of features or the filling of open features. Aspects relating to grade can therefore be quite vague and it is important that parties have a clear understanding on aspects relating to the amount of feature, the size and the filling of open features at the time when product is selected. Small samples or photos do not often convey a realistic perspective of what can be expected. And again, do not assume the other party has a similar view to you. Purchasers also need to realise that every floor is unique and will differ from others in the same product that they may have viewed.

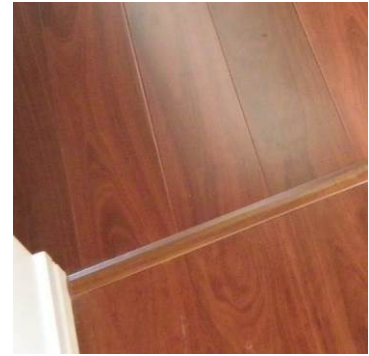
Control joint across a doorway

All these flooring products will swell and shrink with changing weather and internal conditions and installation methods have been developed to accommodate this movement. Particularly with floating floors, trims are an essential part of the installation. As indicated above, several of the problems with floated floors are due to insufficient movement allowance being provided in the floor. Providing appropriate movement allowance for the product, in its laying environment, is a must not an option. When trims, scotia and skirting are installed, it should be expected that they are securely fixed but not to the flooring, and that they provide for unrestricted movement of the floor. It is for this reason and particularly with floated floors that the caulking of gaps to vertical surfaces and to the likes of skirting should not occur. Restriction to natural movement of floor will generally be considered an installation problem. When trims and scotia are installed it is expected that they would provide a neat and tidy finish and complement the floor installation in terms of appearance.
