## Information for floor installers and owners of timber flooring

This information is provided for guidance when a timber floor has been inundated with mud and silt laden water typical of what has occurred in Queensland in January 2011. It does not apply to inundation from sea water and is limited to appearance of performance aspects of the exposed flooring product.

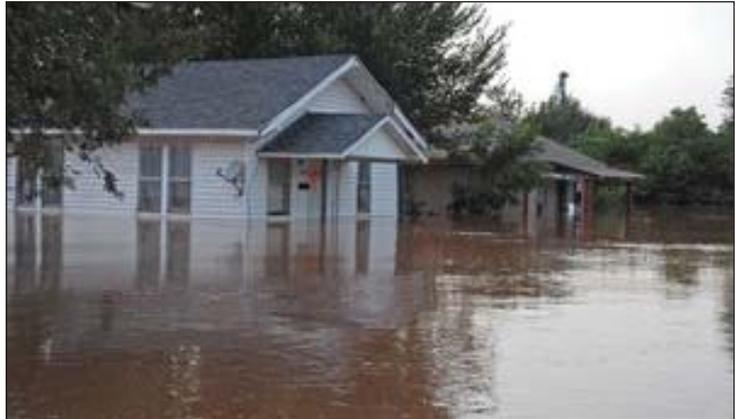
Where the flooring has been laid on sheet structural subfloors of particleboard or plywood it is unlikely that the floor will be recoverable, although even if the floor is not recoverable it may be possible to recover the sub-floor. In either situation it is still necessary to remove the mud and silt as quickly as possible and due to the inundation that has occurred, it is appropriate to hose clean and then use a wet and dry vacuum cleaner or towels etc. to remove remaining surface water. In the less likely situation of trying to retain the floor, dehumidifiers may then be used to provide gentle but consistent drying above the floor.

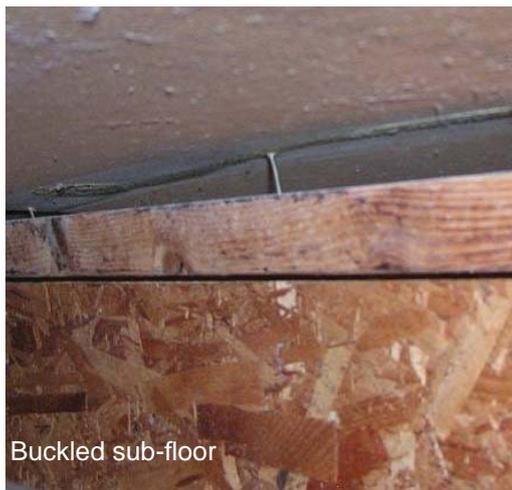
The next aspect to be considered is the fixing of the sheet flooring to the joists. Removal of existing floor, the wetting of the sheet subfloor and joists, and the age of the subfloor may all have had an effect on the fixing strength. Do not assume that because the previous floor had been performing well that you do not need to consider this aspect. Particularly with fully adhesive fixed floors there can be large forces generated that can arch the subfloor off the joists. It is therefore recommended that all retained sheet subfloors are additionally screw fixed to the joists with particular attention to the fixings through the middle of the sheets. In flood affected areas we would also consider that new sheet subfloors are also to be screw fixed in accordance with the manufacturer's recommendations.

Particleboard in particular where retained is likely to swell at board edges and as such the subfloor needs to be prepared correctly prior to the laying of the new floor. Adhesives require clean dry surfaces and therefore to provide this and remove any swelling at sheet edges, the subfloor should be completely rough sanded. If there are any underlying concerns with adhesion, then tests can be undertaken. Test pieces, of the flooring to be used, that are about 400 mm long and with adhesive over half their length, can be used in various areas, left 24 hours and then lifted to test bonding strength. Industry laying recommendations for timber floors over sheet subfloors should be referred to.

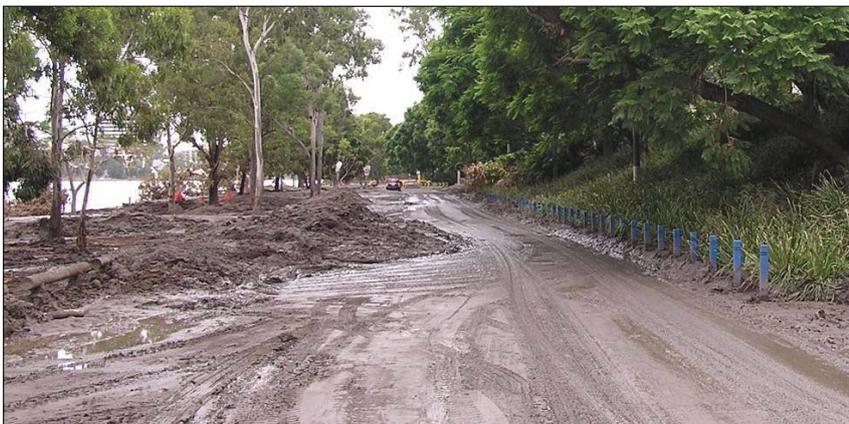
Mud and silt from the Brisbane River in 2011. The water rose to height exceeding the embankment to the right and inundated businesses and apartments.

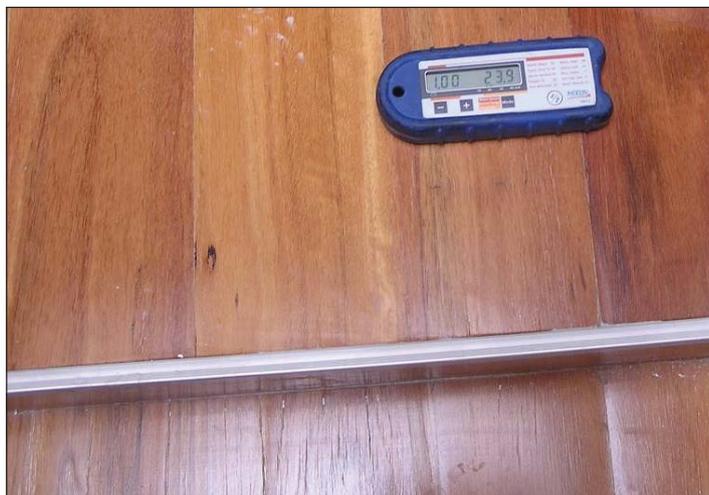
This engineered floor direct stuck to the slab was submerged in the Brisbane flood of 2011 with about half a meter of water over the floor. This photo is about 10 days after the flood. The plywood core layer remains high in moisture content but the floor although having a crowned appearance is still firmly fixed to the slab. The water had also resulted in some expansion in the floor and checking (or splits) in the surface. Greater moisture penetration was evident at board end joints and board ends abutting walls and doorways. A similar direct stuck floor that had been removed had minimal mud and silt beneath.

We would expect that in most instances these floors irrespective of whether they are laid on plywood, battens or direct to slab, that they will need to be replaced due to entry of mud and silt and difficulties in drying these floors. Although, in some situations direct adhesive fixed floors could be recoverable and in such instances steps to remove mud and silt from the surface and drying as outlined above may be employed.
